Mainline Inspection Services

Date 7/11/2011 10:14:37 AM Report Date 7/25/2011
Type Sewer and storm drain video inspection.
Purpose To inspect and locate the residence's main sewer line and outside storm drain. Determine whether storm drain ties into sanitary or to city storm sewer.

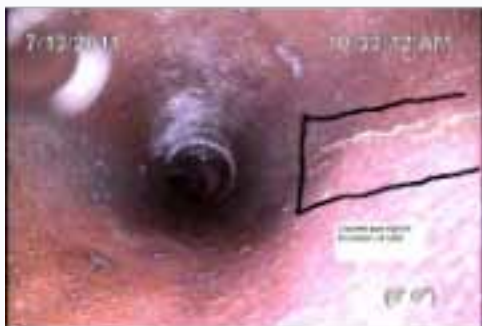
Count 0' 0"

Cracked pipe at the bottom of the toilet.

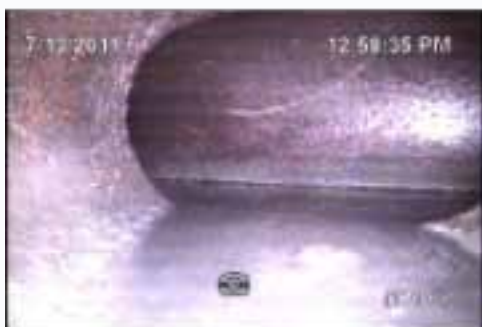
Count 1' 10"

Tie-in to main sewer line. Marked with letter "D" on basement floor.

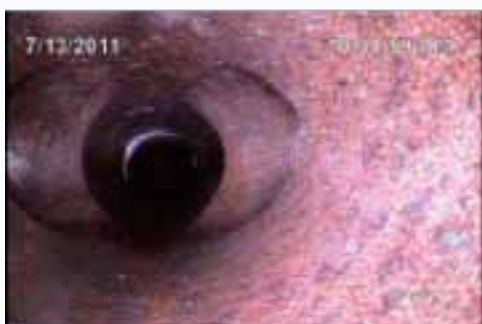
Count 2' 6"

2 Tie-ins into main sewer line. Flow test indicates both are downspout lines.

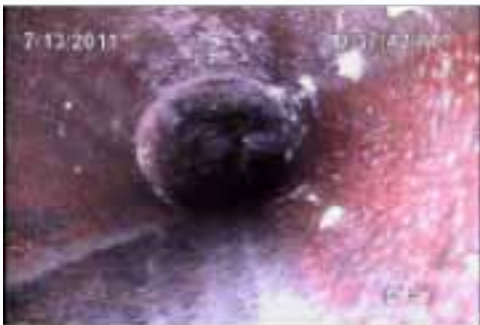
Count 4' 9"

Debris at the top of the pipe and tide mark indication of a prior backup.

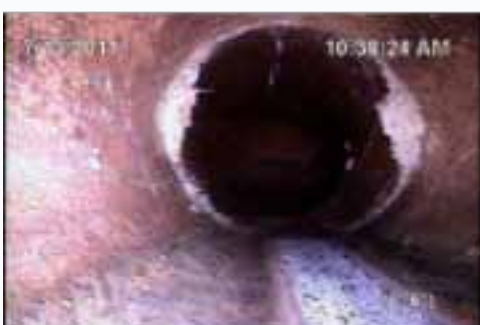
Count 8' 6"

Roots coming in at joint.

7/11/2011 10:14:37 AM**Purpose** Inspect and locate main sewer line.**Summary****Recommended Action** Might want to consider getting sewer mainline jetted and treated with Root-X.**Quote****Job Location**1234 Main Street
Anytown, OH 45000**Customer Information**John Smith
1234 Main Street
Anytown, OH 45000**Inspector Information**Patrick Hooper
1206 West Loveland Avenue
Loveland, OH 45140

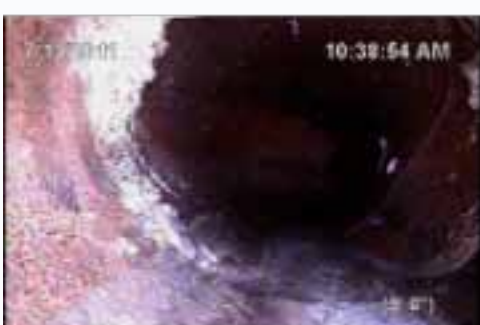
Count 9' 0"

Some cracks in the pipe, 45-degree turn.

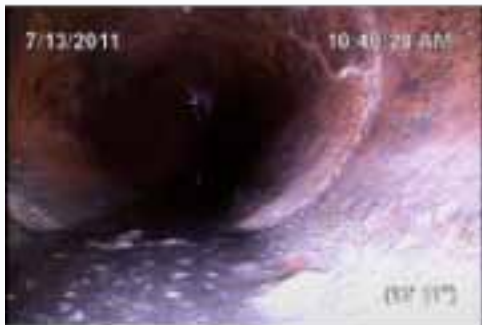
Count 12' 11"

Cracked pipe in upper right-hand corner of frame.

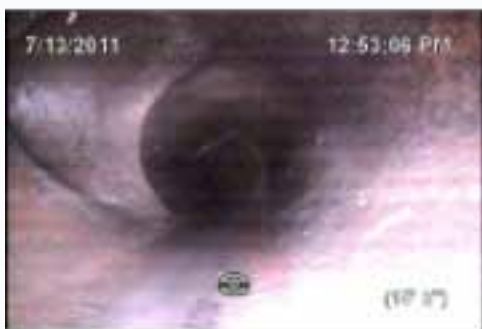
Count 15' 2"

Tie-in on left side of frame marked with letter "C" on the basement floor. Flow test indicates a connection to stack from second floor.

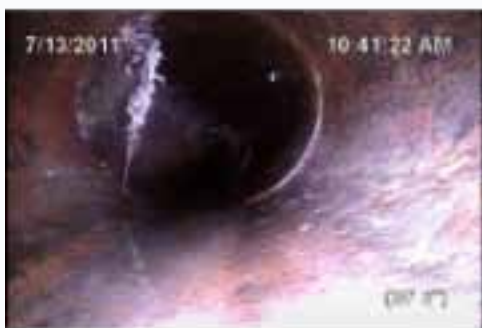
Count 20' 6"

Roots in the line.

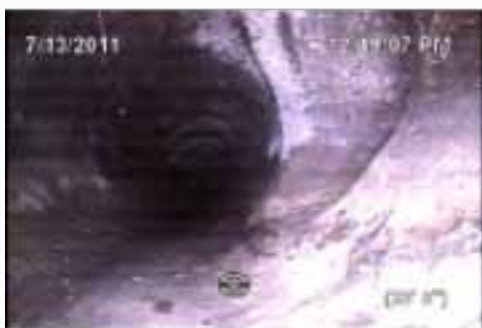
Count 23' 3"

Tie-in on right side marked with letter "B" on the basement floor. Flow test indicates connection to basement sink and floor drain.

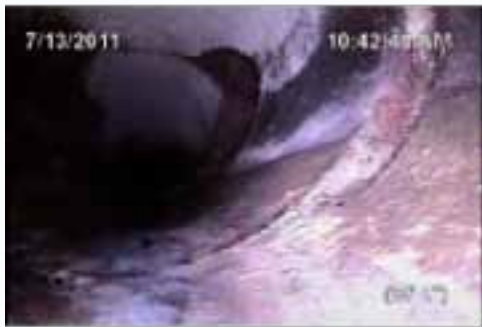
Count 29' 2"

Separation in the joint.

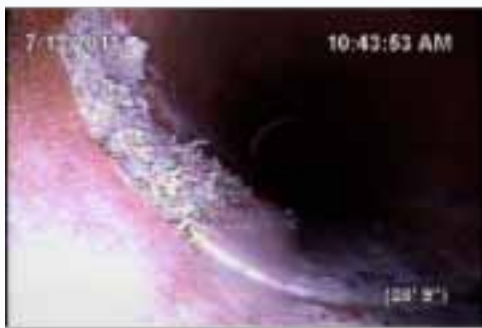
Count 38' 9"

Roots in the line.

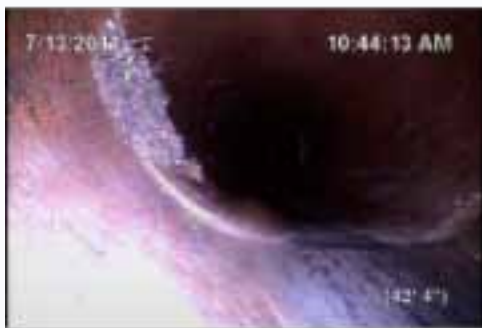
Count 42' 4"

Roots in the line.

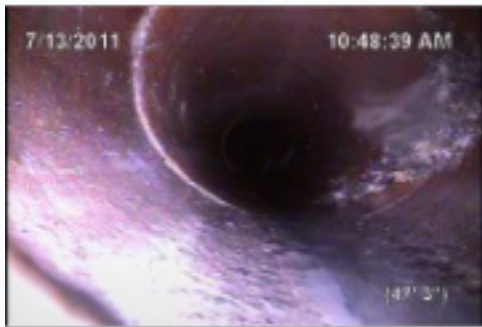
Count 47' 3"
Roots in the line.

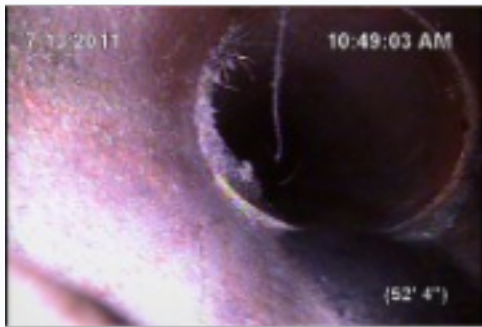
Count 52' 4"
Roots in the line.

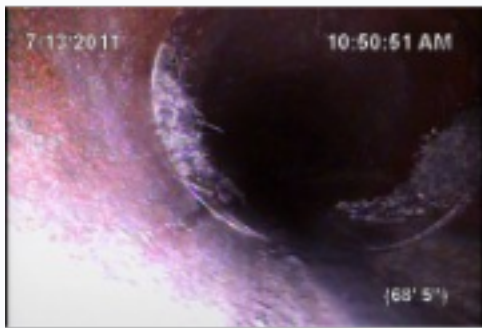
Count 68' 5"
Roots in the line.

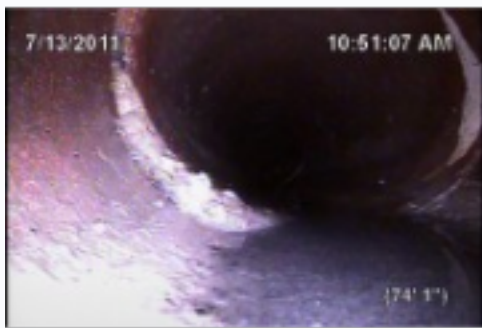
Count 74' 1"
Roots in the line.

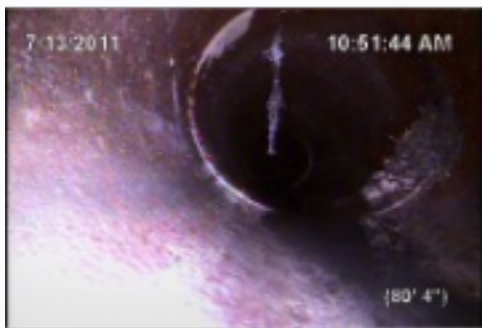
Count 80' 4"
Roots in the line.

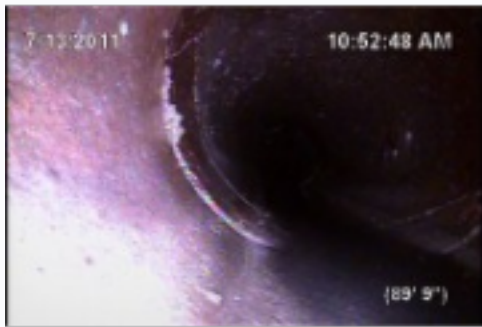
Count 89' 9"
Spiral crack in pipe.

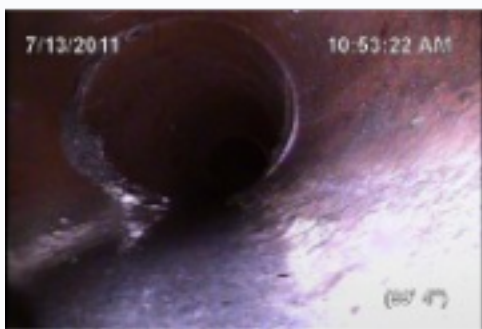
Count 99' 4"
Roots in the line.

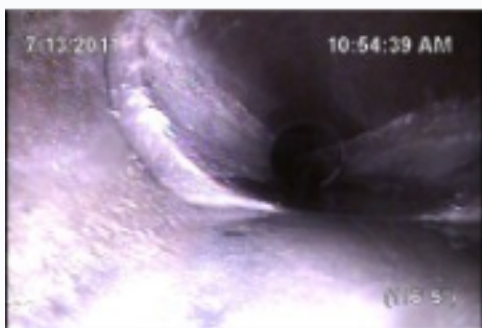
Count 116' 5"
Offset in joint.

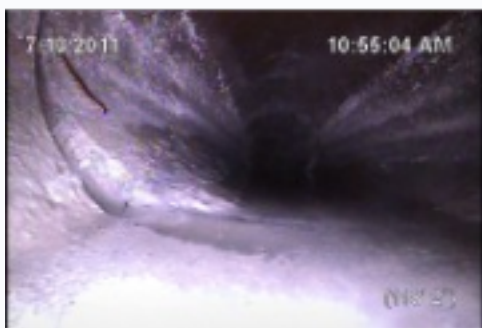
Count 118' 2"
Offset in joint.

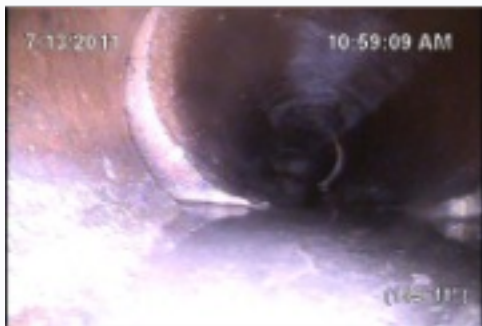
Count 149' 11"

Offset and city tie-in about 10 feet further down the pipe. Could not make it to tap due to offset in the line.

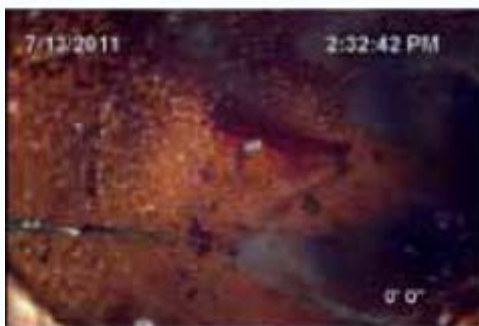
Count 0' 0"

Cracked pipe at bottom sweep of 2-inch stack.

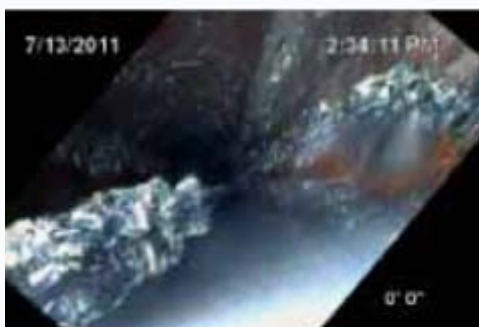
Count 0' 0"

Grease and additional debris in the line from the 2-inch stack into the main sewer line.

7/13/2011 2:29:28 PM**Purpose** Inspect stack in rear of garage.**Summary****Recommended Action** Jett out grease build up.**Quote****Job Location**1234 Main Street
Anytown, OH 45000**Customer Information**

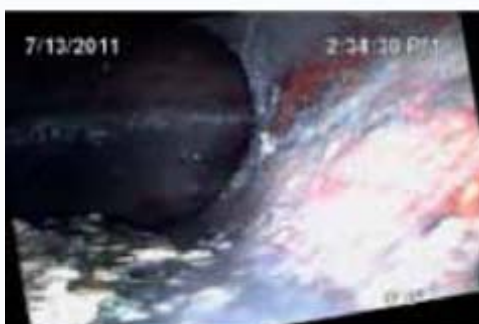
Count 0' 0"

The tie-in of the 2-inch stack into the main sewer line, marked with letter "F" on the basement/garage floor.

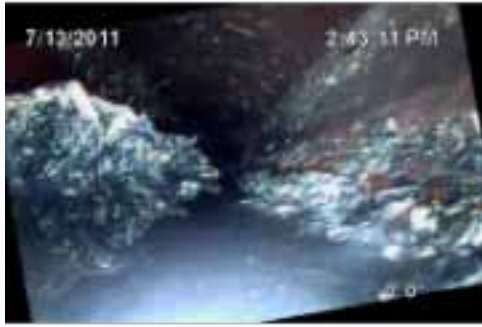
Count 0' 0"

Additional grease and debris just before connection to main sewer line. The tie-in is marked with letter "F" on the basement/garage floor.
